# Colorado Forestry Best Management Practices

## *Forest Stewardship Guidelines for Water Quality Protection*

2014 Field Monitoring Report

August 2017

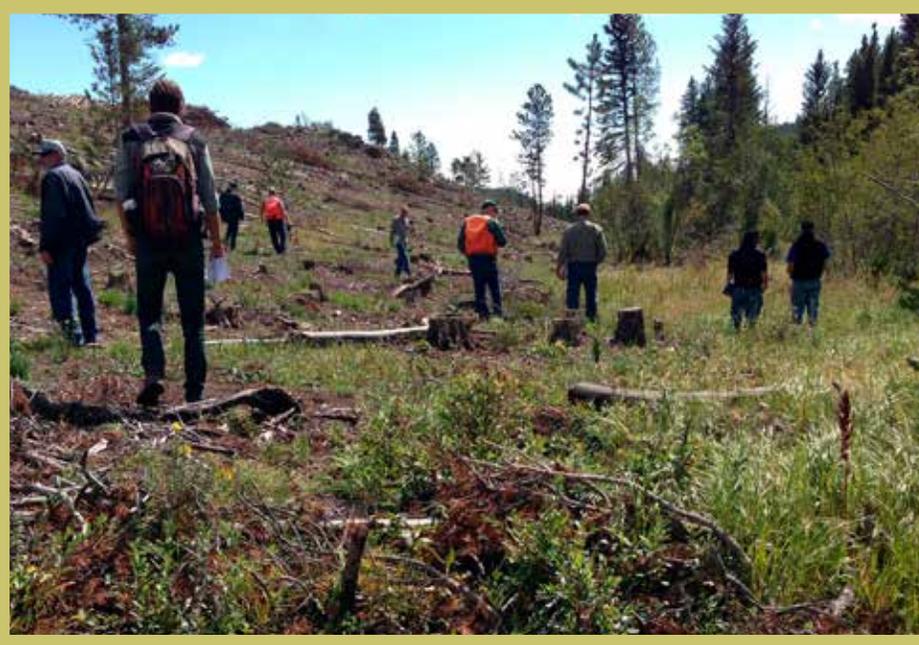
*Figure 3: The monitoring team inspects skid trails and the Streamside Management Zone (SMZ). Photo: Peter Ismert, U.S. EPA*

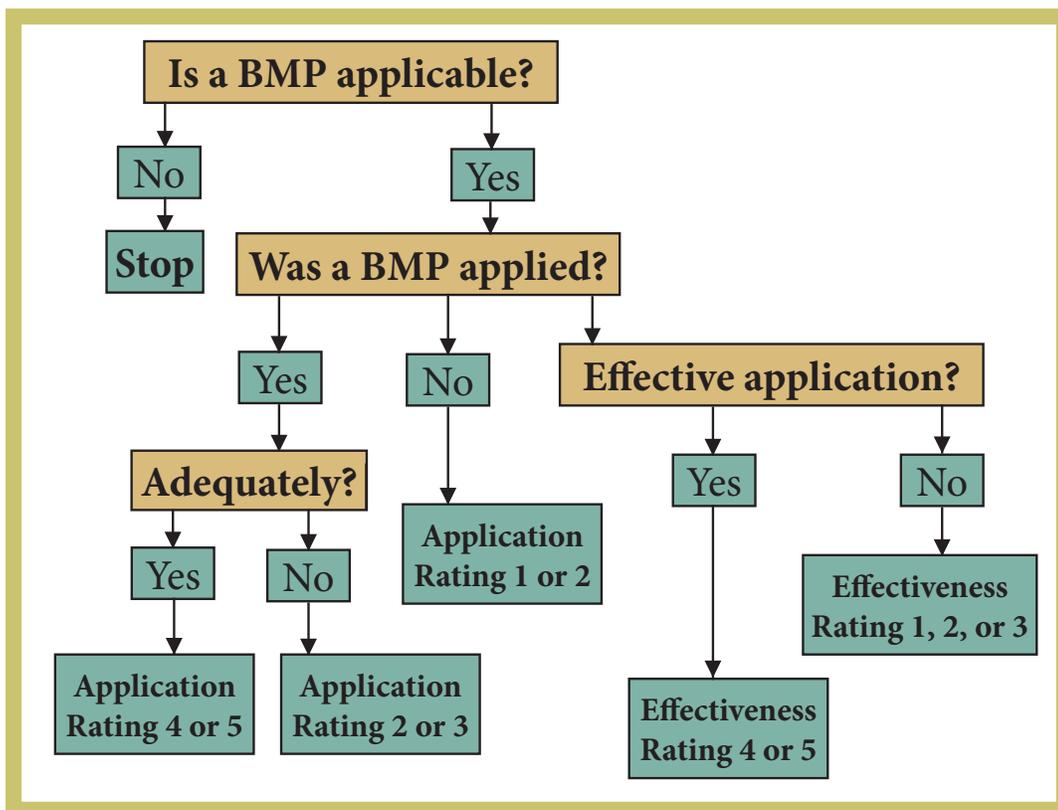
Figure 5: Colorado BMP Audit Ranking System

The rating process conducted for each BMP item begins with establishing whether the BMP in question is applicable to the harvest activities under consideration (see Figure 5).

For example, not all harvest sites require the construction of temporary roads. In these cases, the BMPs that pertain to temporary roads are not applicable. Once the monitoring team establishes that a given BMP is applicable, the application rating for the BMP is determined, based on written criteria (Table 1).
